THAMES RIVER BASIN  
STERLING, CONNECTICUT  
**STERLING POND DAM**  
**CT 00610**

PHASE I INSPECTION REPORT  
NATIONAL DAM INSPECTION PROGRAM

DECEMBER 1980

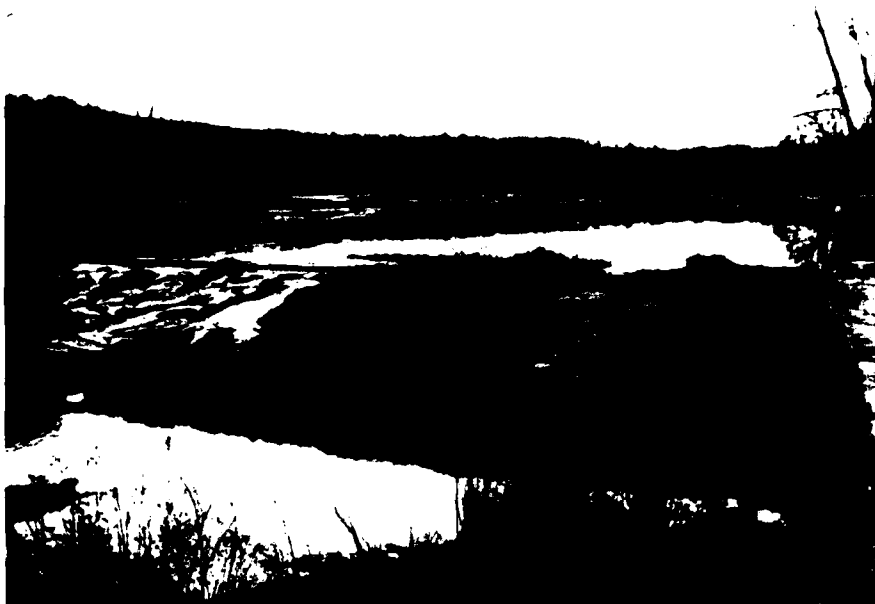
Auxiliary Spillway #1 - A wood railroad tie extends across the length of this spillway, raising the crest about 3 inches (Photo 5). The masonry is quite rough with missing mortar and some weeds growing from the surface of the weir. Although no flow was going over the weir, there was substantial flow in the discharge channel (Photos 1 and 5). Most of the flow is through a 3 foot diameter hole on the center upstream side of the spillway which then continues through the weir.

Photo 5 - Auxiliary Spillway #1 at left end of dam  
(Nov. 1980).

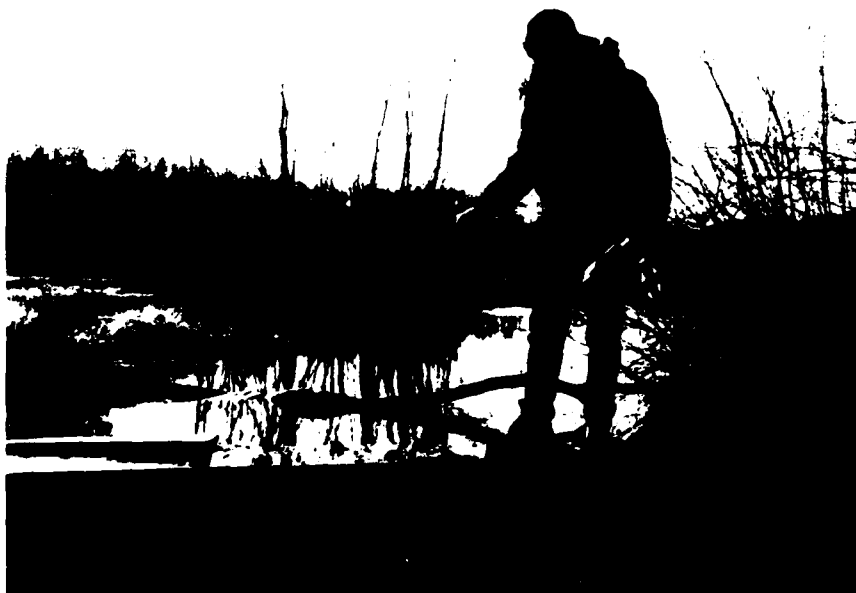
1. The flow through the auxiliary spillways could lead to failure of these structures if allowed to continue.
2. Seepage at the downstream slope could lead to failure of the embankment and masonry sections of the dam, and should be investigated.

Photo 8 - Hole which carries most of the flow under  
Auxiliary Spillway #2 (Nov. 1980).
